MedSun: Newsletter #45, February 2010

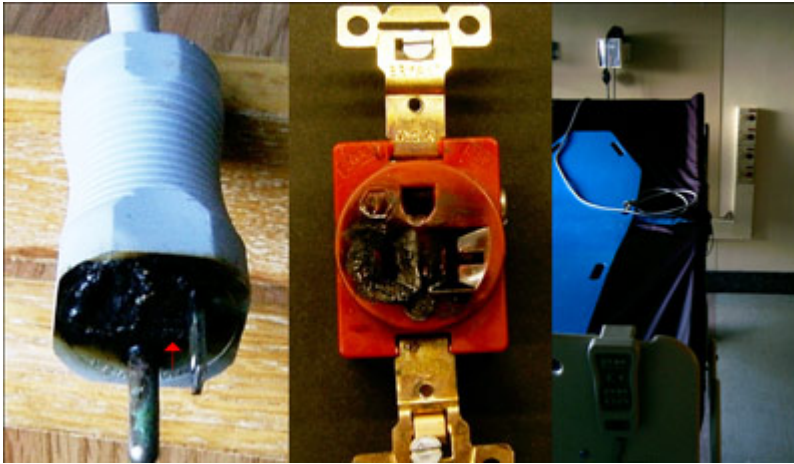
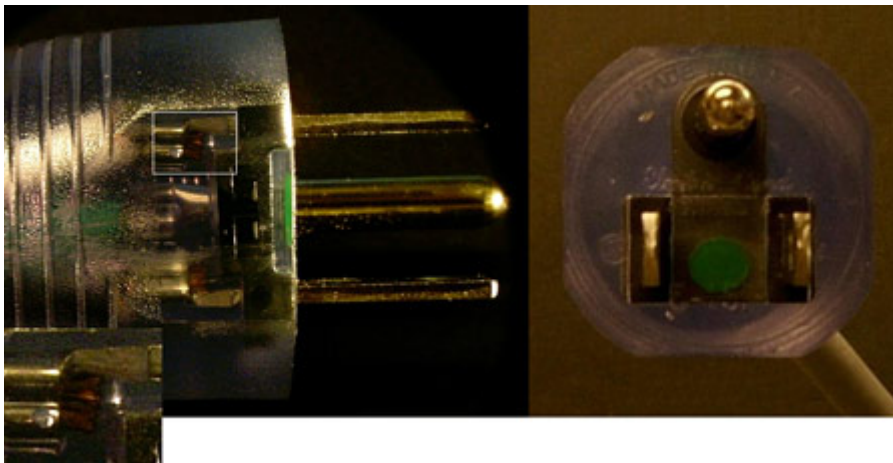
I informed our rental rep (we only rent these beds when needed), and the rental company, of the event and of the problems other manufacturers have had with this same type of power cord plug.

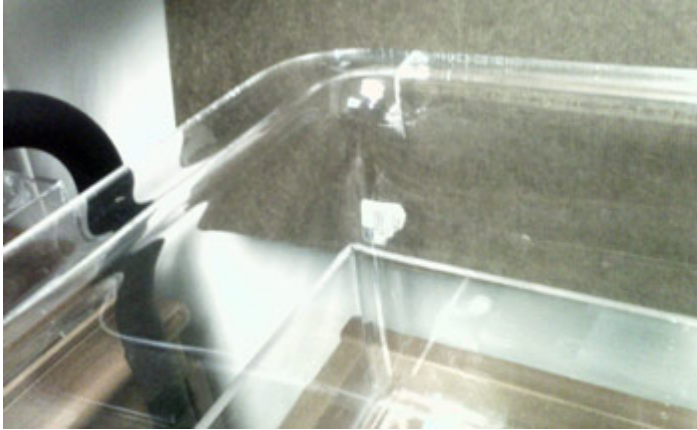
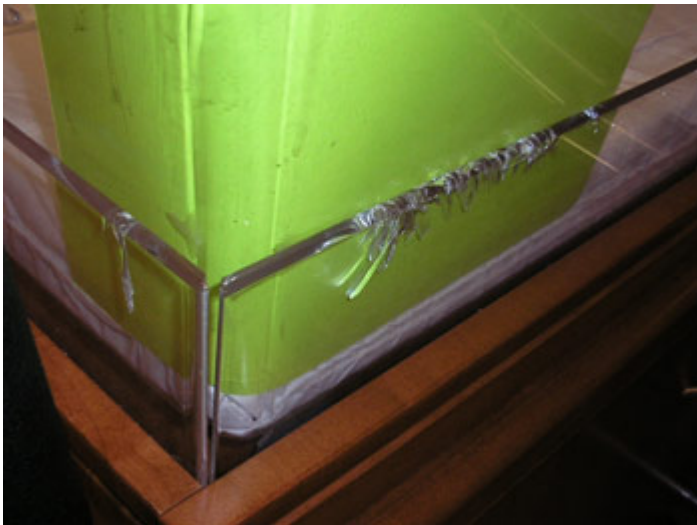
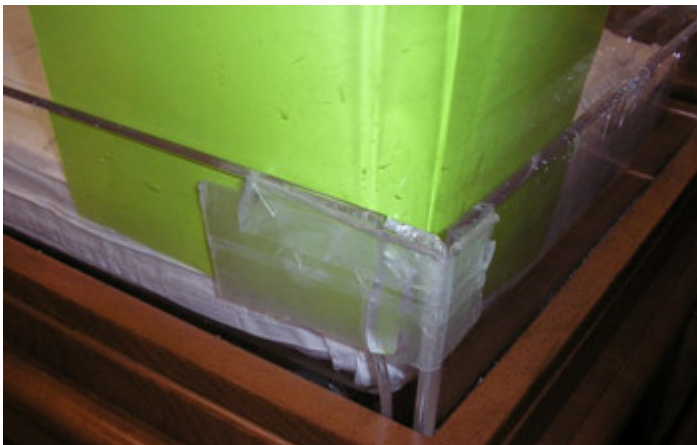
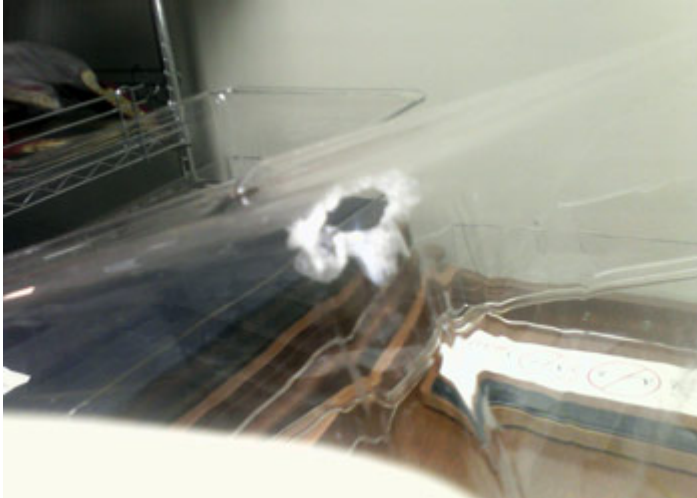
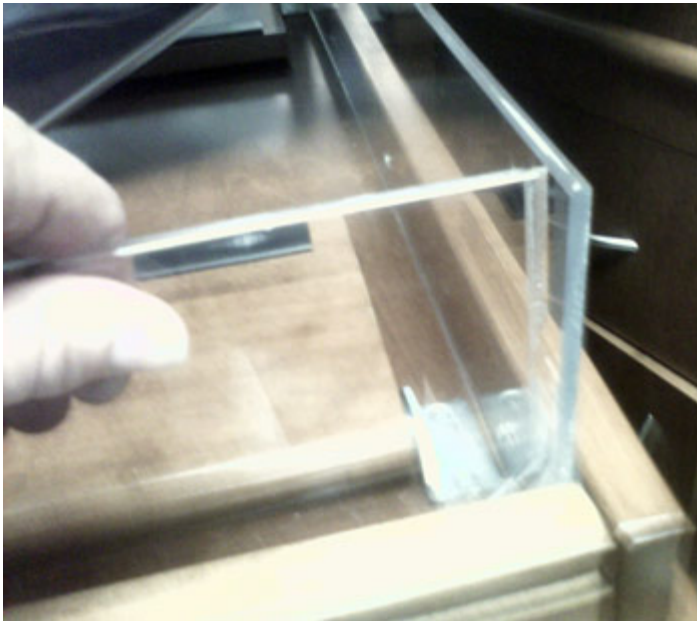
Since early winter this year, we have had problems with our newborn bassinets cracking, breaking, and developing holes in the corners. Drawers/doors swing open and won't stay closed, carts hard to push, wheels don't roll smoothly. Plexiglas piece along the top of the bassinets were all replaced by the company approximately four months ago. Currently have 11 bassinets not usable. Have pictures of problems I can send.

Manufacturer response (as per reporter) for Bassinets that fit into wooden carts, Newborn bassinets: Initially the company stated that the carts/bassinets were not being handled correctly. Plexiglas parts were replaced and they are all breaking/cracking again. Representative came again and took pictures and I took pictures. We asked if any other

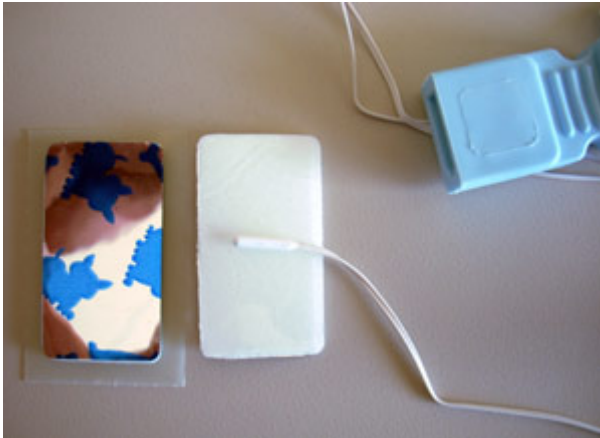
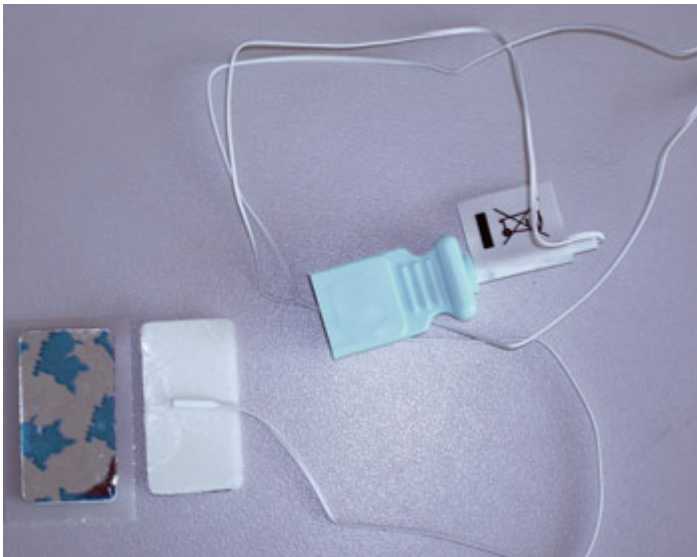
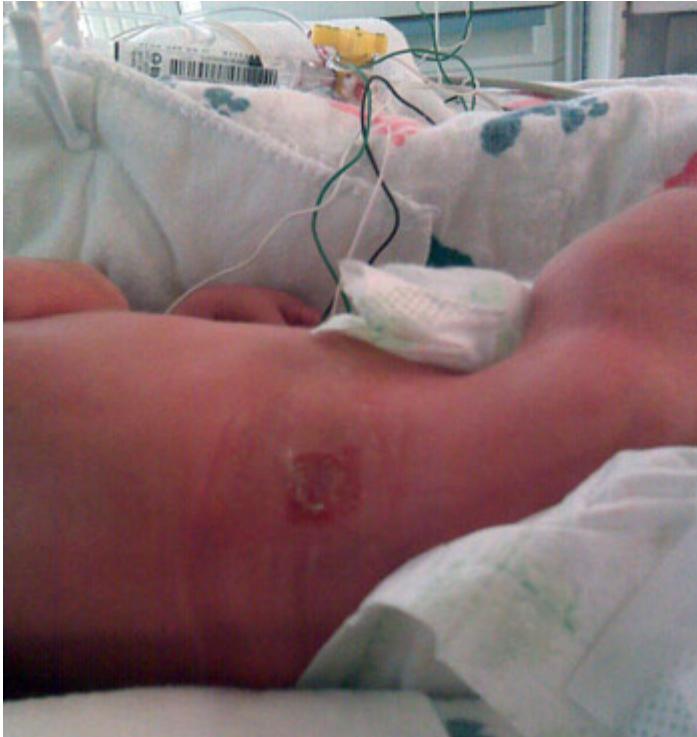
Noted area of skin breakdown directly under temperature probe cover on infant's right side of back. Area measured approx 2.5cm X 3cm. Area appeared excoriated almost like a burn, with discolored drainage formed on top of wound. The burn probably was a second degree burn. The nurse did not report any damage to the pad.

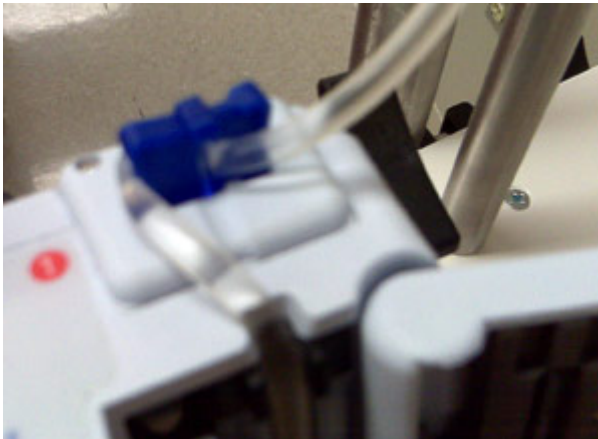
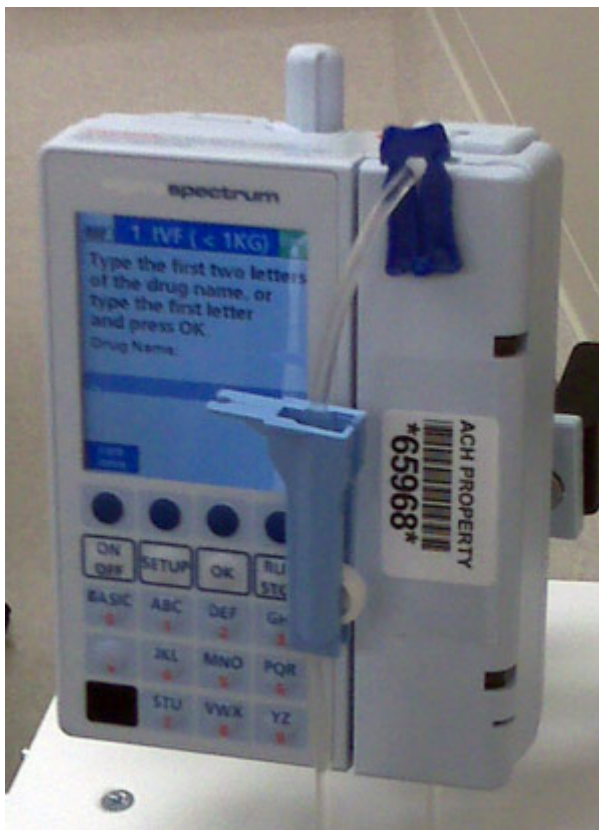
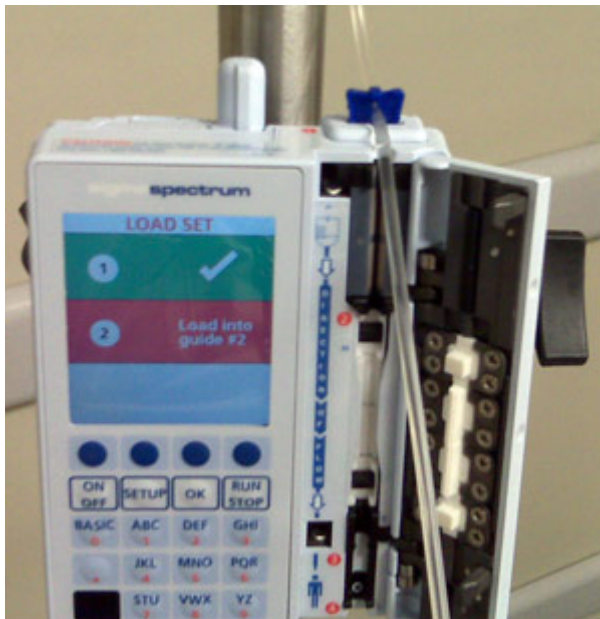
We feel that the design of pump channel and/or IV tubing loading process allows a clinician to easily misload IV tubing if the clamp slides too far down the tubing (away from the first access port). The loop caused by this positioning of the clamp (which is also the key to open the pump door) made it difficult to determine which tube was the distal end of the tube.

We attempted various ways to misload the tubing in a way that will "trick" the pump into working, and found two ways to do this easily. The pump design relies on its labeling as well as the nurse remembering to trace the IV line from the bag to the patient on every load. There does not seem to be any safe guard against this human factor in the design of the pump. However, the pump does alarm with an "occlusion" if it is started with misloaded tubing, but there is nothing to prevent the tubing misload from happening in the first place.

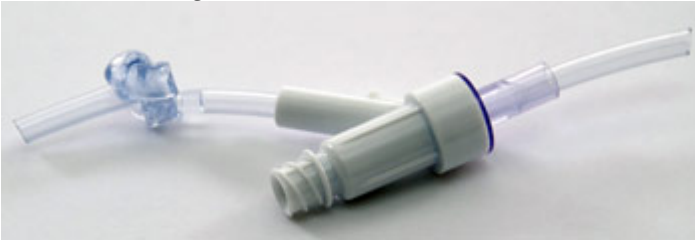
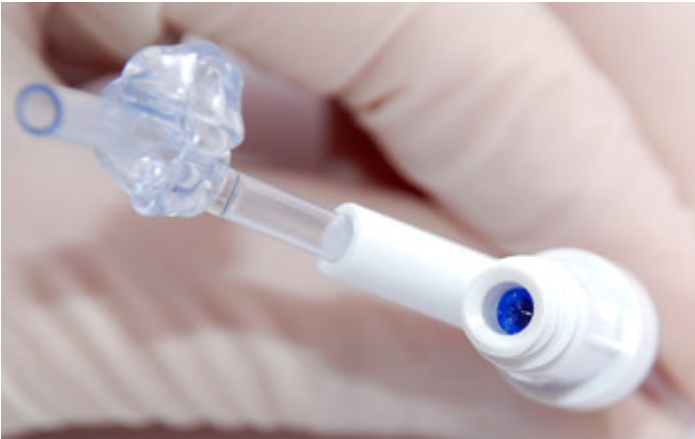
We experienced two episodes with defective Braun primary IV tubing today in the ICU. The first episode involved the injection port on the primary infusion line closest to the patient. The port was leaking out a significant amount of blood on a critically ill patient. The port was used for injection prior to finding the leak.

The second episode was similar, but involved a different patient and the injection port immediately after the pump. Again, the patient was bleeding back and out of that port with a significant amount of blood collected on the floor. Another nurse reported the same type of defect on an IV tubing last week. She saw that the blue stopper did not pop back up after injection.

The only explanation the nurse had for the failure is that a syringe may have been connected to the port to deliver medication, and when it was removed, the plunger did not return to the closed position. However, that has not been verified.

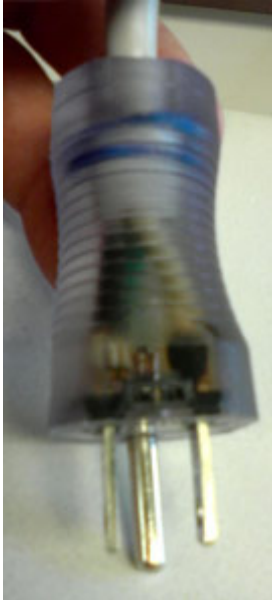
The Fresenius hemodialysis machines AC power cord with the black plastic bridge, which is manufactured by a power cord manufacturing company exhibited charring at the neutral wire in the molded clear colored plug.

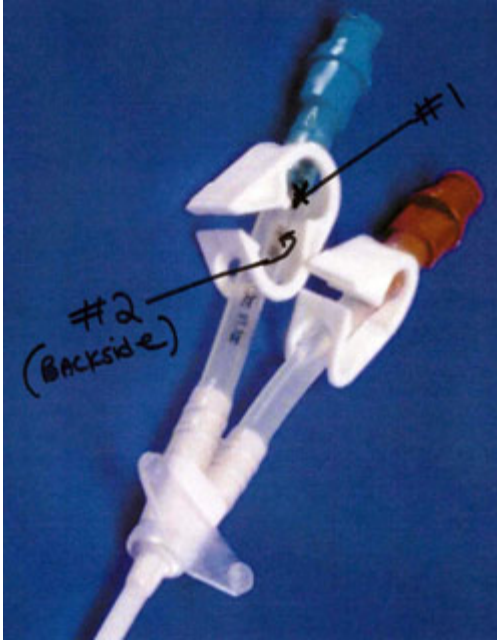
A patient was undergoing a stem cell collection through a right internal jugular DL Mahurkar catheter. It was noted that there was a pin hole leak in the plastic tip of the blue lumen of the (11.5F/16 cm DL Mahurkar Dialysis catheter) catheter. The catheter was pulled. The patient had enough stem cells collected from a prior day and the catheter was no longer needed. In addition a similar occurrence with another patient happened about a month earlier to this reported event where a pin hole was noted in the same catheter. This occurred with a different size catheter (11.5F/19.5cm DL Mahurkar Dialysis Catheter). The pin hole was also noted in the plastic tip of the blue lumen while the patient was undergoing stem cell collection. This patient returned to interventional radiology to have another catheter inserted and the stem cell collection procedure was resumed the following day.
